## STRUCTURAL ASSESSMENTS CAN HELP BUILDING OWNERS AVOID COSTLY REPAIRS

### PARKING GARAGE ASSESSMENT: *DMS HURSTON GARAGE*

## STRUCTURAL STABILITY AND SAFETY: SWAN AND DOLPHIN BALCONY SURVEY

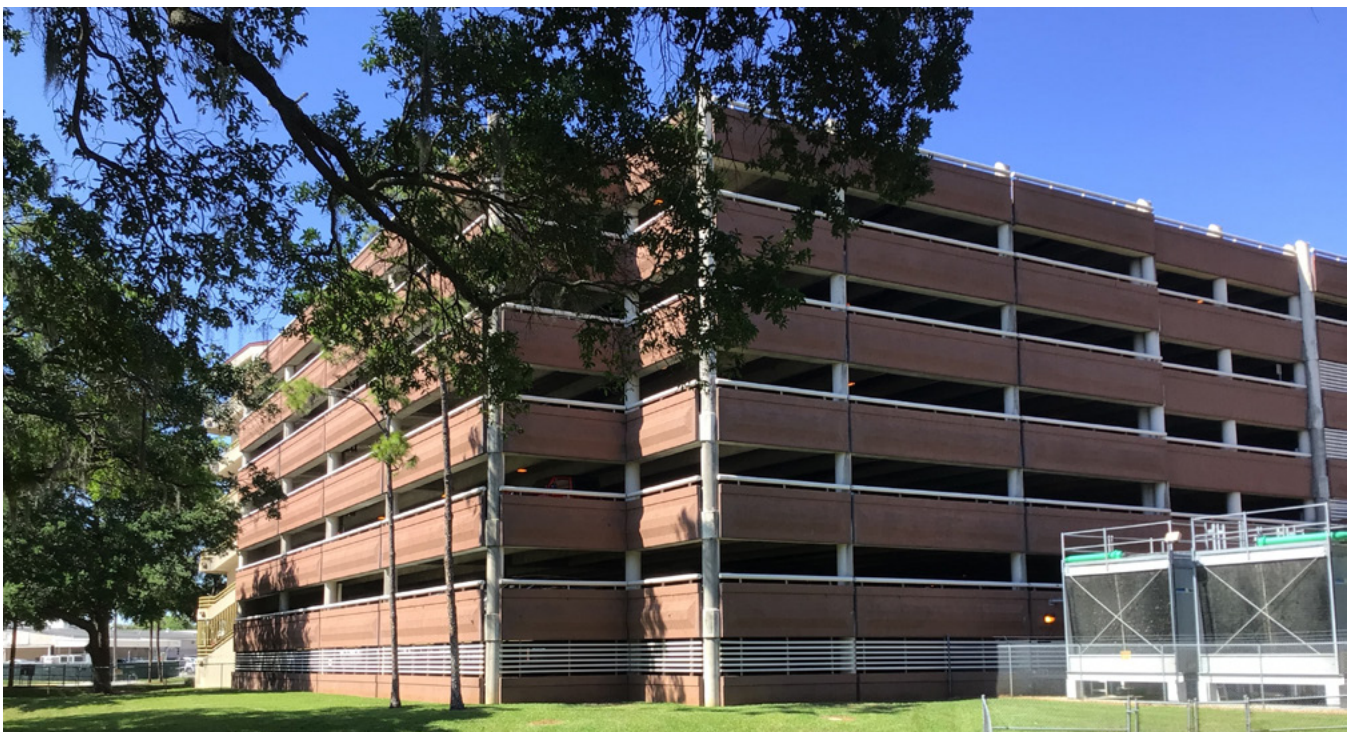
TLC's structural team conducted a condition assessment of the entire multi-level parking garage. TLC also provided construction documentation for repairs, waterproofing, threshold inspection, and construction administration. Some conditions observed throughout the garage included cracked concrete, spalled concrete, exposed reinforcing, corroded Cazaly hangers, corroded barrier cables (some cables broken), and delamination of the top-level waterproof traffic coating.

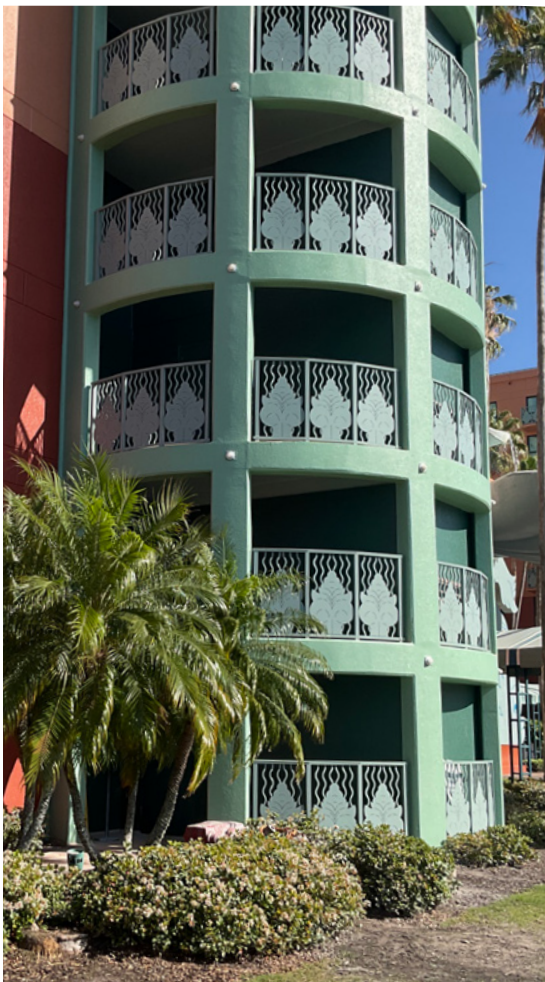
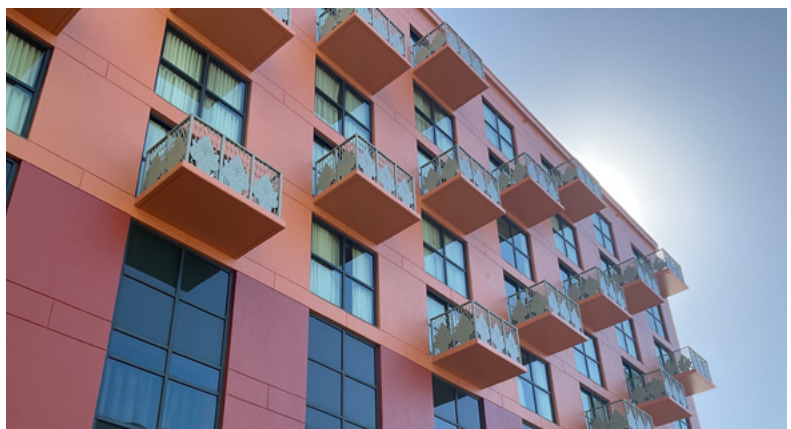
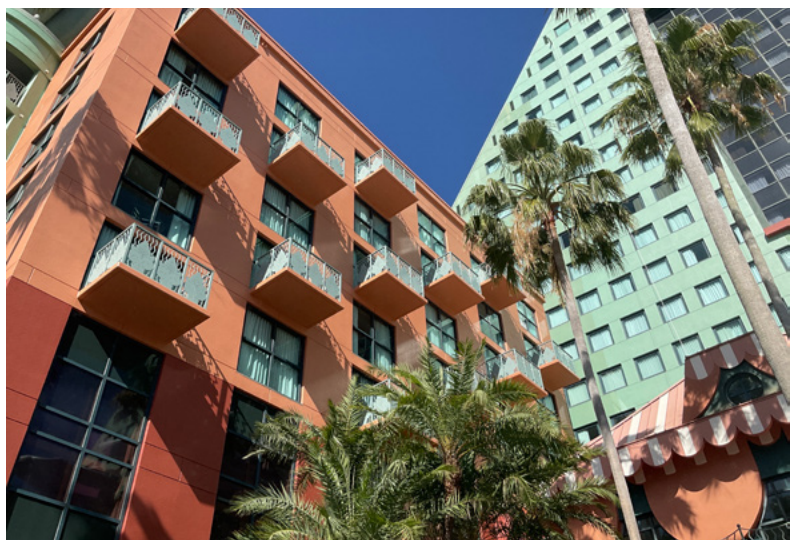
To ensure the stability and safety of these balconies, TLC conducted individual condition assessments for each. Any signs of damage were documented, and repair drawings were provided to address any issues observed. TLC served as threshold inspector during the repairs, ensuring the repairs were completed correctly. As with all reinforced concrete structures, the balconies are susceptible to concrete spall, which occurs when the steel reinforcement corrodes, causing it to expand and crack the surrounding concrete. While, hot and humid weather can accelerate the corrosion of steel reinforcing, routine inspections and timely repairs can ensure safety and prevent any issues from becoming costly and severe.
